NATIONAL TRANSPORTATION SAFETY BOARD

MATERIALS LABORATORY FACTUAL REPORT

Report No. 13-083

Place : Paulsboro, New Jersey
Date : November 30, 2012
Vehicle : Conrail Freight Train FC4230
Operator : Consolidated Rail Corp. (Conrail)
NTSB No. : DCA13MR002
Investigator : Paul Stancil, RPH-20

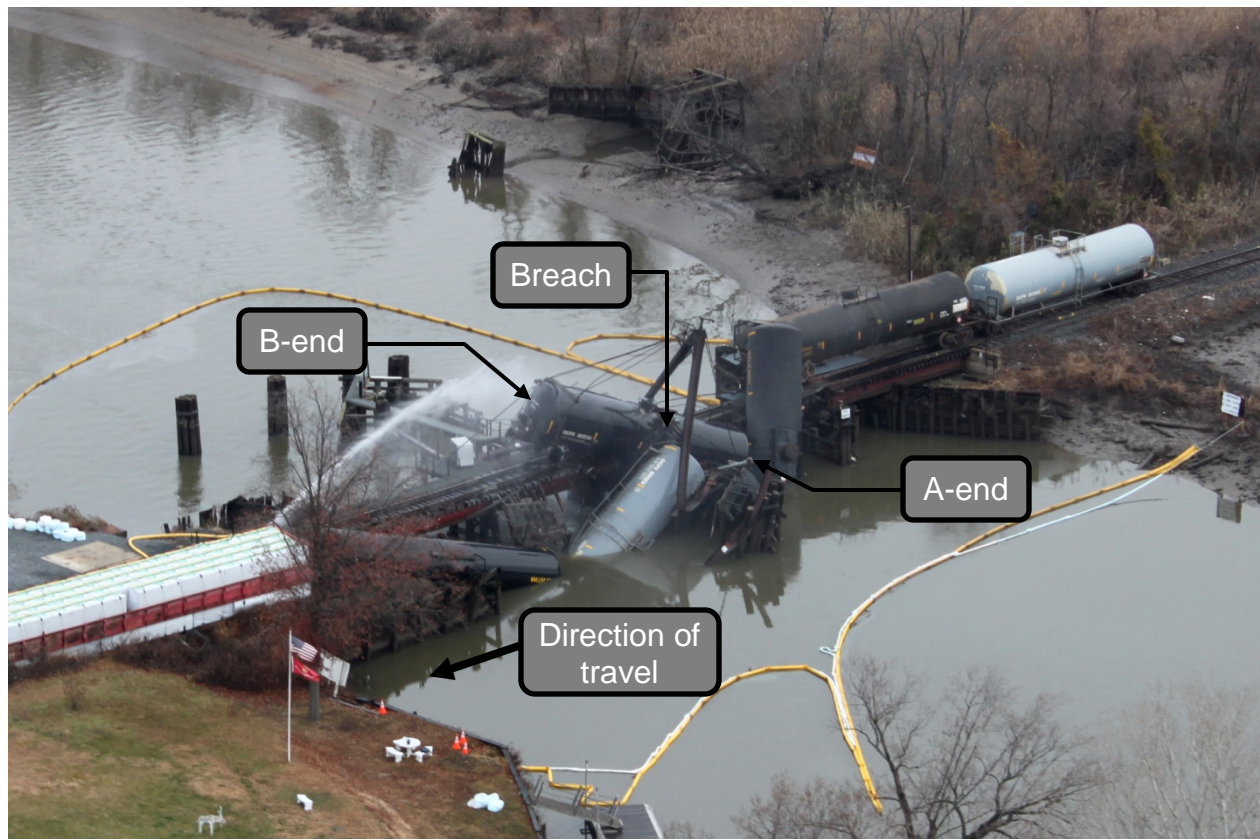
Four tank cars that derailed on the bridge came to rest with portions of the cars in Mantua Creek. Three of the derailed tank cars that entered the creek contained vinyl chloride, and one contained ethanol. One of the tank cars was breached during the derailment and released approximately 20,000 gallons of vinyl chloride into the environment (see figure 1).

Figure 1: Aerial photo with the A-end, B-end, and approximate location of the breach in the tank car identified.

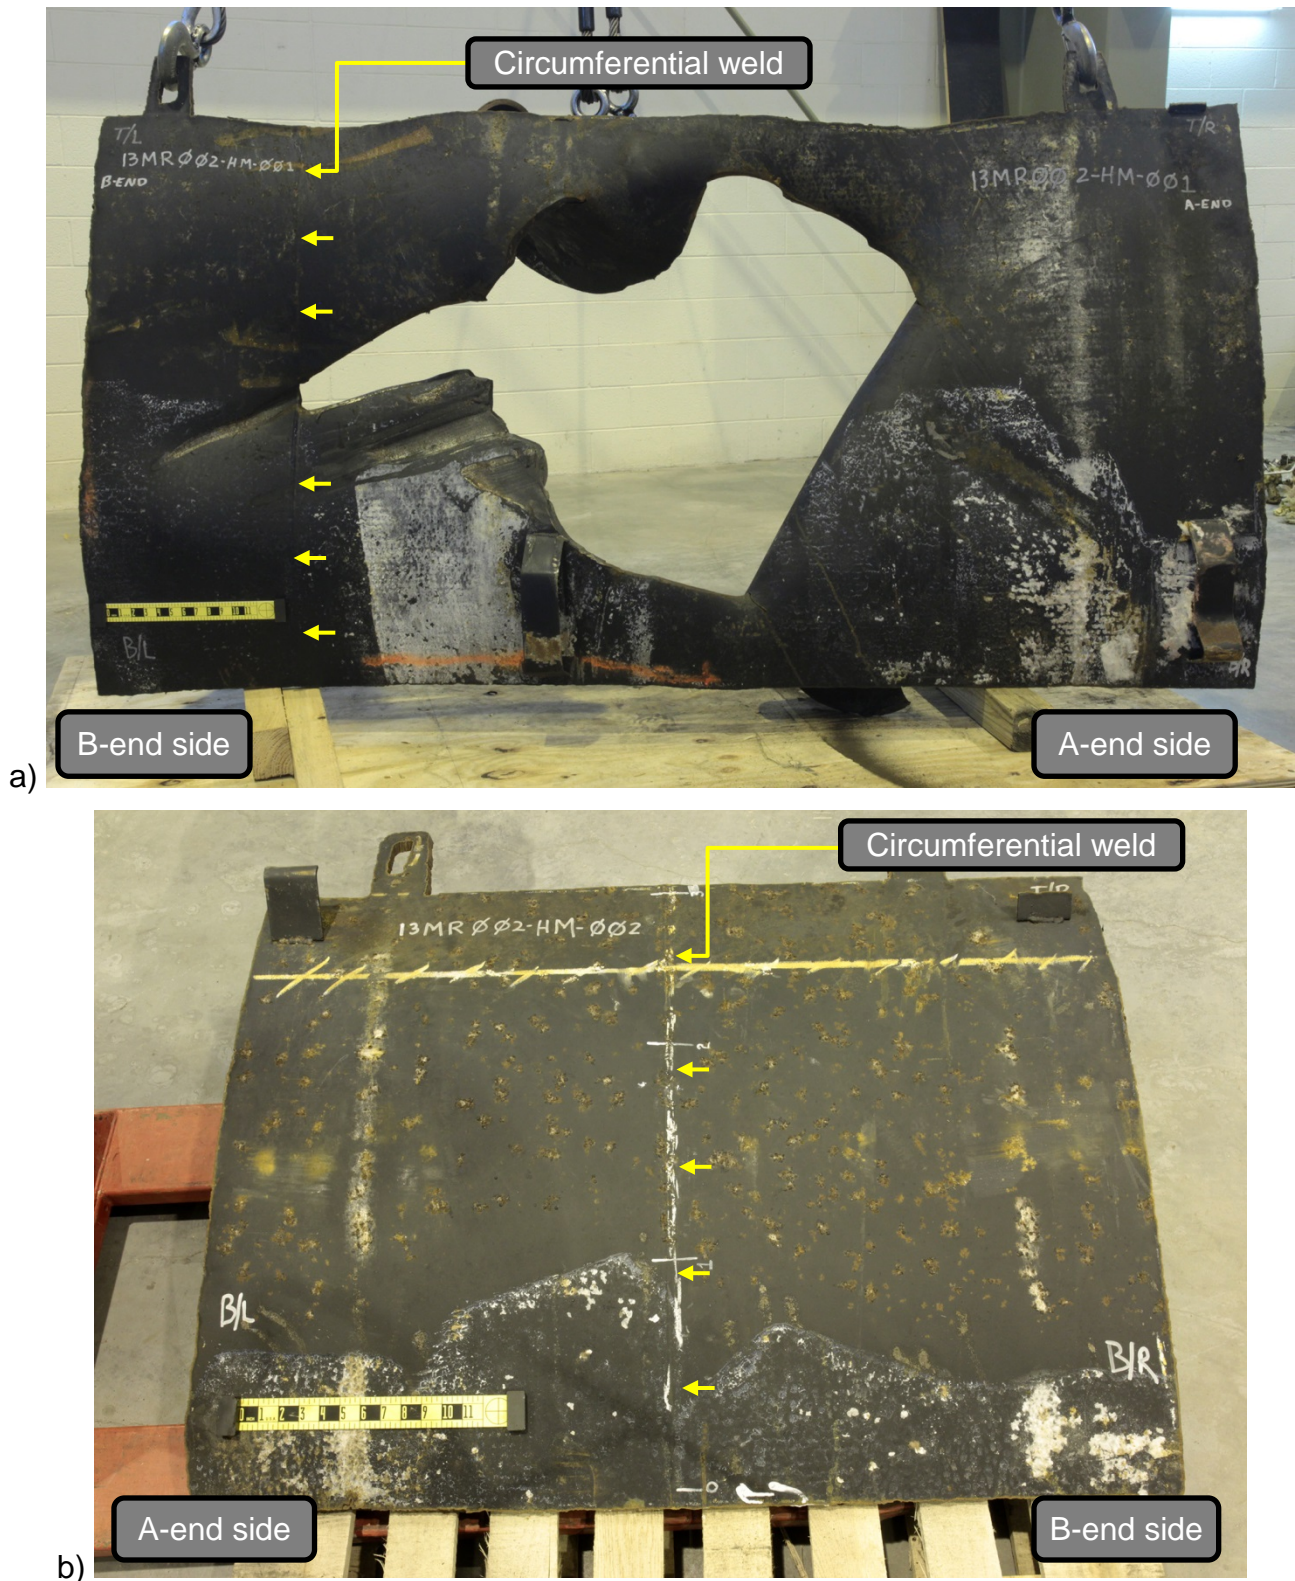
Figure 2: a) 4 ft by 8 ft section of vinyl chloride tank car OCPX 80234 containing the breach and b) 4 ft by 3 ft section from the opposite side of the tank car containing the same circumferential weld and ring material on either side. The location of the weld on each section is indicated by a series of yellow arrows.

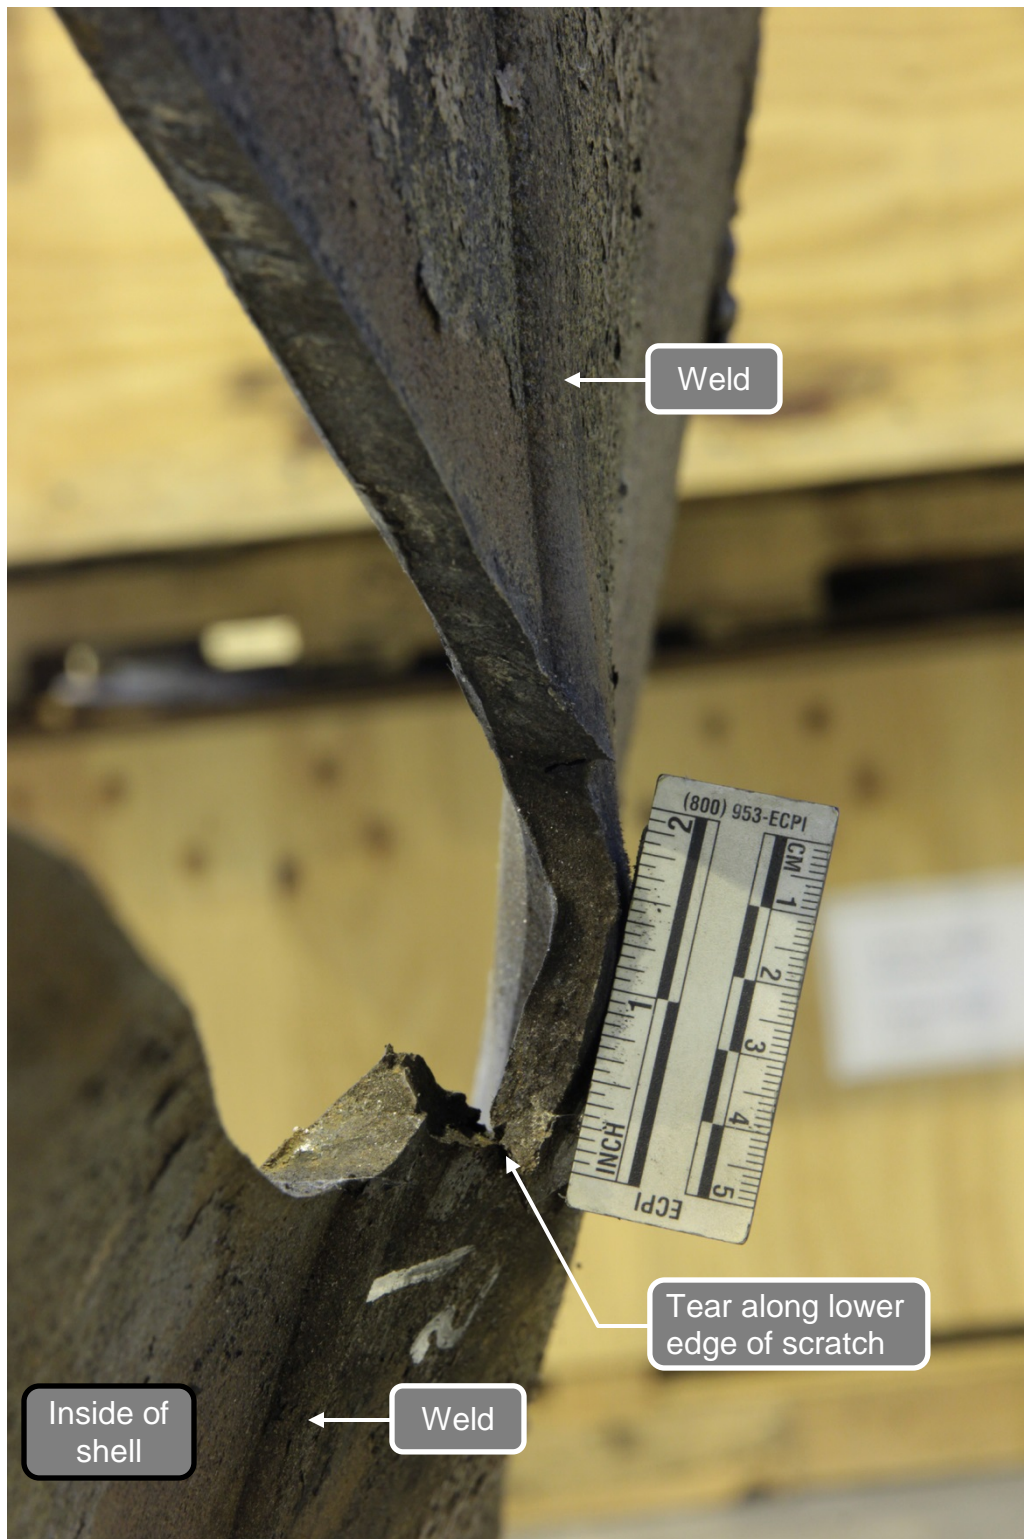
The breached section of the tank was examined visually and the dimensions of several features were measured using a steel ruler and measuring tape. There was a scratch track on the outside of the tank that started approximately 13 inch from the weld on the B-end side, as shown in figure 4, and increased in width and depth until it intersected the weld. Near the toe of the weld, the scratch was approximately 2.0 inch wide and 0.7 inch deep (figure 5). There was a tear along the lower edge of the scratch track that started at the toe of the weld and extended 2.8 inch back toward the B-end (figure 5).

Figure 5: View of where the breach initiated, looking down the longitudinal axis toward the B-end of the tank car.
